Presenters:

# Good Enough – Hitting the Energy Jackpot at Wentworth Community Housing

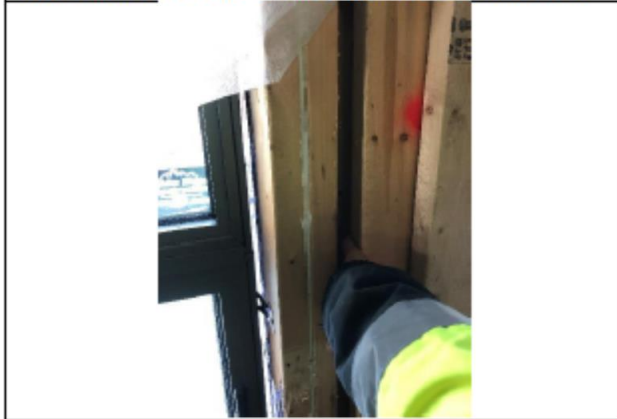
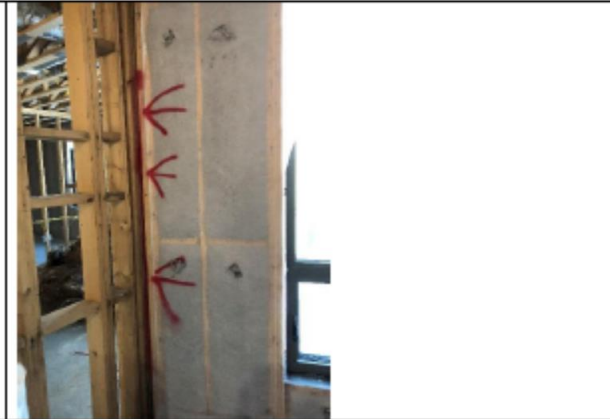
The bays where an interior wall meets the exterior wall wrap behind a turned stud making access to the bay difficult. Because of this the plan is to drill and fill the bays with cellulose.

The arrows above point to a bay missing insulation at the intersection of column lines 5 and 6 on the 2<sup>nd</sup> level. Fill the bay with either cellulose or foam.

Results: Overall the cellulose insulation is looking good. The bays that are filled are densely packed with cellulose as it should. A few areas on the first floor were marked with red spray paint which represent bays missing insulation. The majority of them are known by the insulator such as the bays where interior walls meet exterior walls. The plan for them is to drill and fill the bays with cellulose. Along with this, bays that are too narrow to fill with cellulose should be filled with can foam instead.

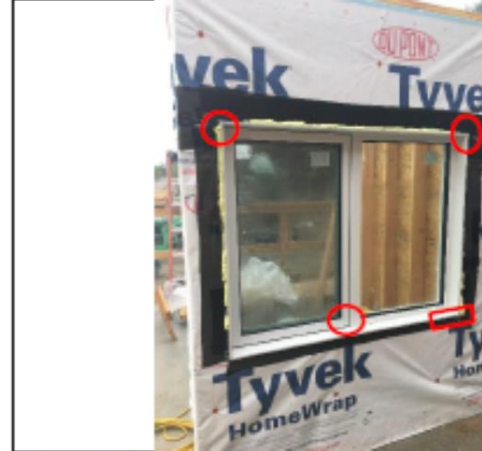
The installed window from outside. Locations where leaks were found are shown and described further below.

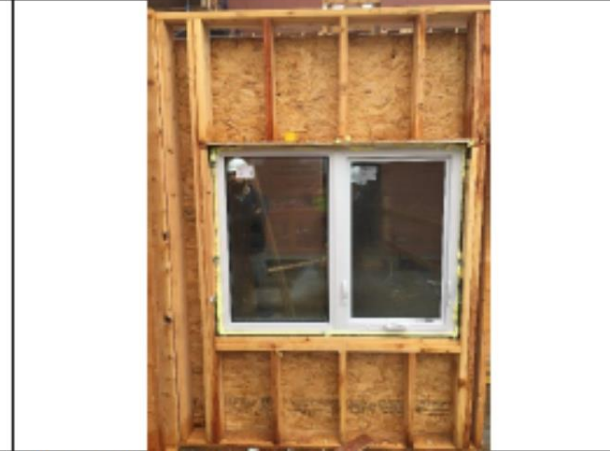
The installed window from inside.

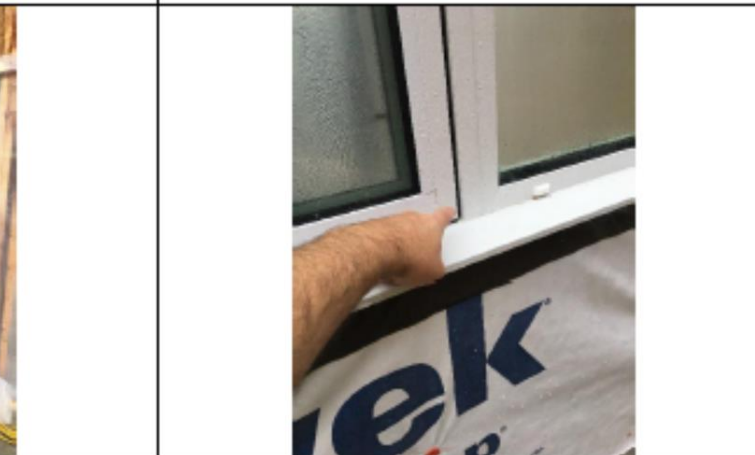
Fog wisped out at the lower corner of the sash even though the cam lock was engaged. This is not a major concern but highlights the importance of making sure the frames are installed square so the sashes close as they were designed to.

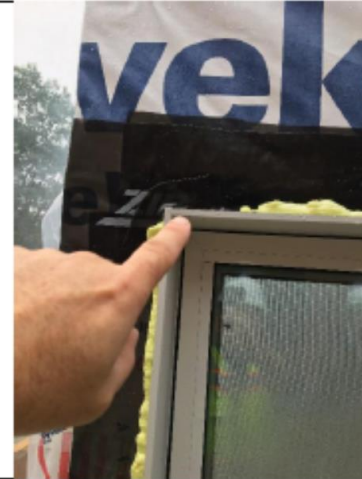
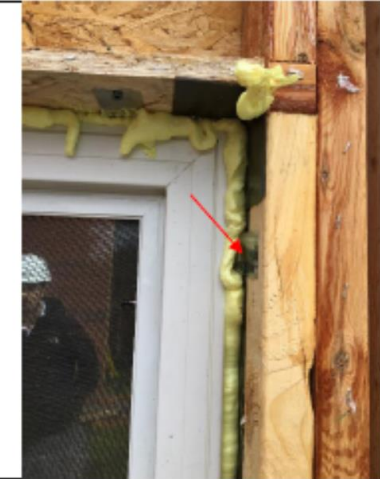
Fog leaked at the foam in the corner when introduced at the clip shown at the right. See related recommendation above.

Results: Mark Selig from ReArch was concerned with the drywall seal to the foundation in the parking garage. In speaking with Mark, he stated that the interior rigid insulation in Drawing A-SK16 is being replaced with closed cell spray foam. If this is true, then we recommend the drywall be installed along the perimeter first, only one (1) sheet wide. This will allow the insulators to spray from the foundation directly to the top of the sheetrock. This transition, if done properly, will last longer and create a better seal to the foundation. The spray foam will also help seal penetrations through the foundation such as the roof drain pipes. Please also indicate where this switch to foam was approved.

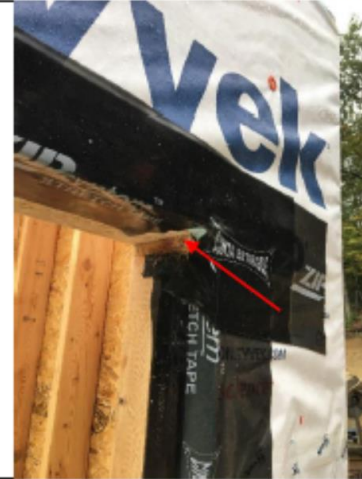
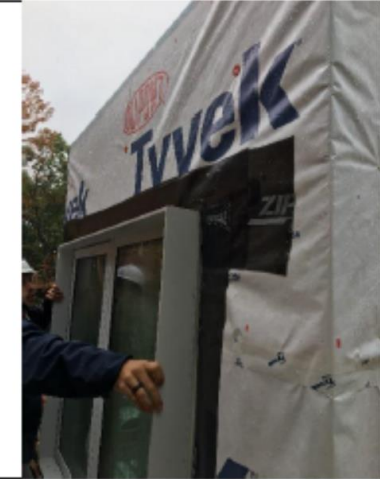
Make sure the ZIP stretch is stretched all the way into the corners. This opening was later infilled with more tape.

Hopefully the rough openings are not too tight. The window could tear the tape as it is pushed in.

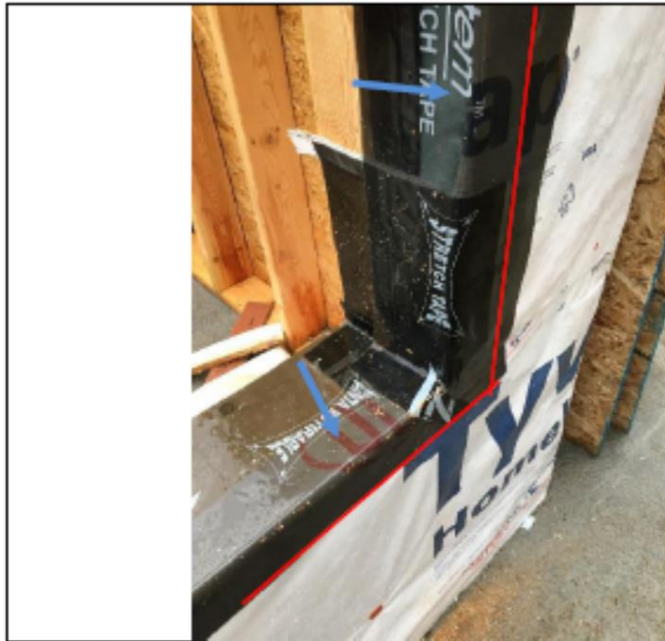
The Tyvek has to be cut back in a square at the outer edge of the window buck so that the zip tape at the sheathing (the air barrier) can connect with the Zip Stretch tape at the rough opening. The Tyvek should not lap into the opening as seen above (blue arrows). The red lines show where the Tyvek should be cut to.

As discussed in the kick off meeting on 9-25-18, the Zip tape at the sheathing has to wrap the nose of the wood buck and the Tyvek has to be cut back to leave the buck exposed so the Stretch tape can connect to the Zip tape and then connect to the Tyvek. This is important for air barrier continuity. Also, make sure the Stretch tape comes into the rough opening far enough that the inner caulk bead will seal to the Stretch tape, not to wood.

It was done correctly at the mockup but a reminder to start at the bottom of the window and work up for proper shingling. This applies to all taped seams on the building.

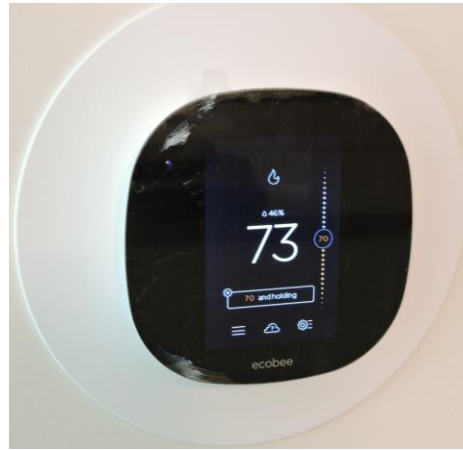
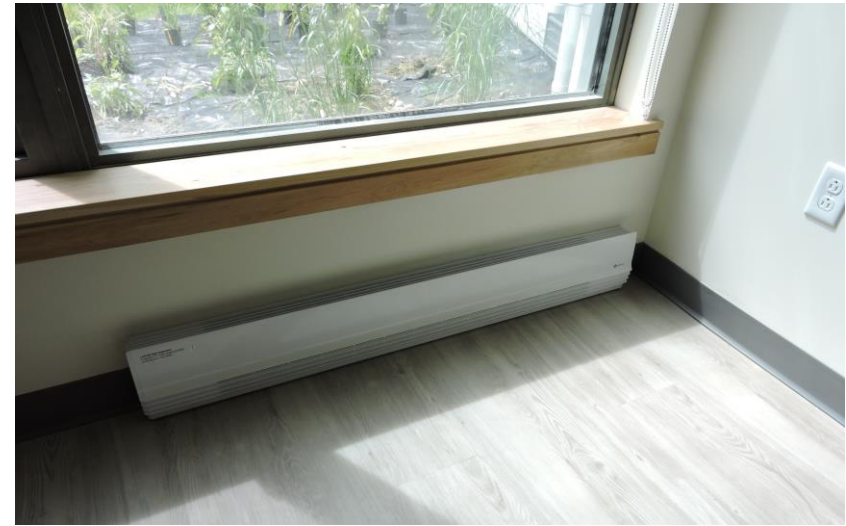
- ✓ Electric baseboard heat
- ✓ ERV with LP gas heat and cooling
- ✓ Condensing water heaters (LP)
- ✓ WiFi thermostats

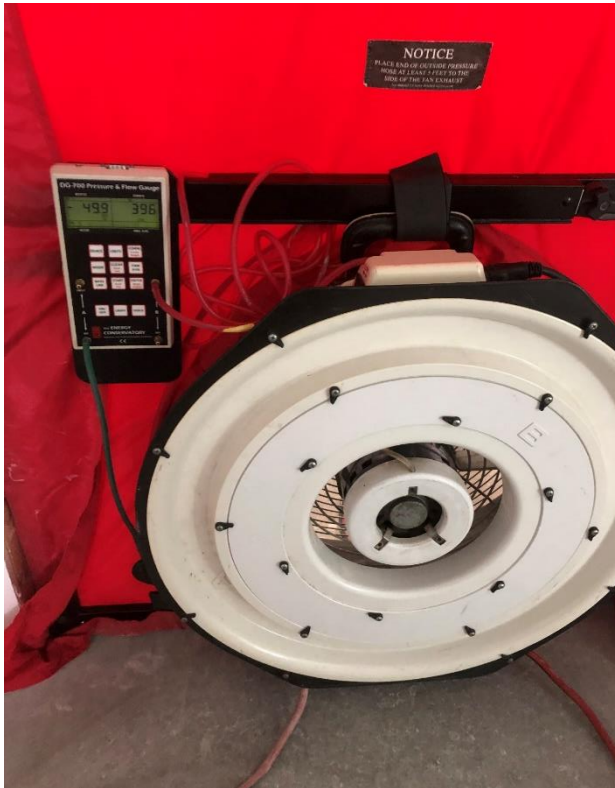
The Unit 110 leakage rate was 369 CFM at 50 Pascals which equates to 0.12 cubic feet per minute (CFM) at 50 Pascals of pressure (1.04 lbs./sq. ft) per SF of the exterior shell. The maximum air leakage rate allowed was .10 CFM at 50 Pascals per SF of exterior shell and 0.20 CFM at 50 Pascals per SF of interior shell equating to 448.2 CFM at 50 Pascals. This result means the unit has met the air tightness standard.

| Field Measured<br>CFM @ 50<br>Pascals | Square Feet of<br>Unit Shell | CFM50/SF | Weighted Target<br>CFM |
| 369 | 2,962 | 0.12 | 448.2 |

Note\* photo was take before repairs were made.

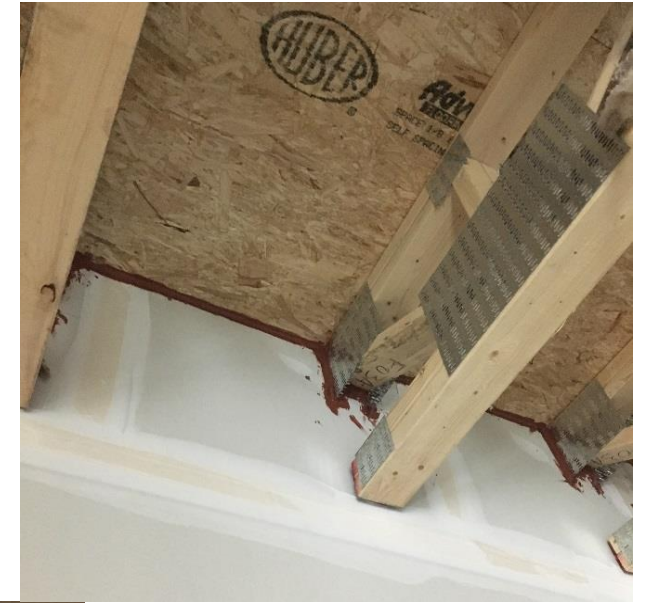
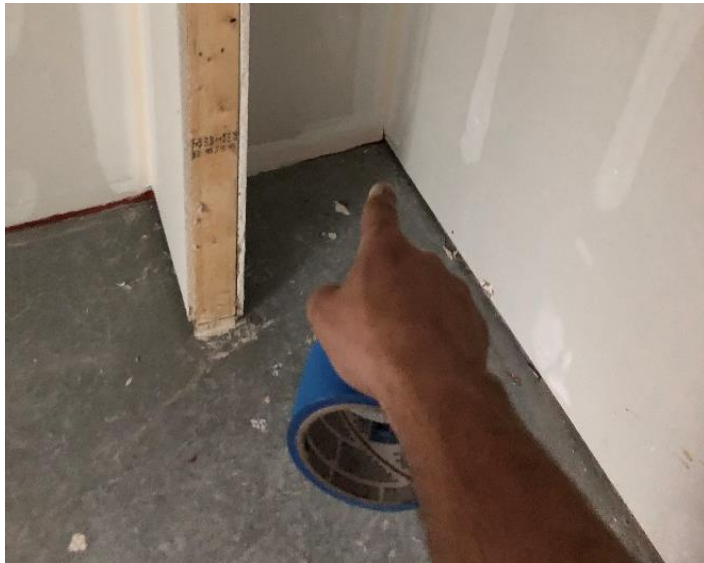
Wall to floor

Drywall is not continuous behind interior partitions, resulting in leaks.

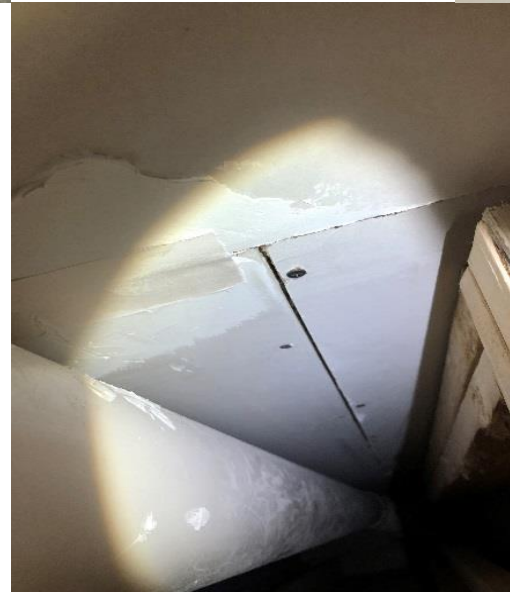
Pipe chase with seam missing tape

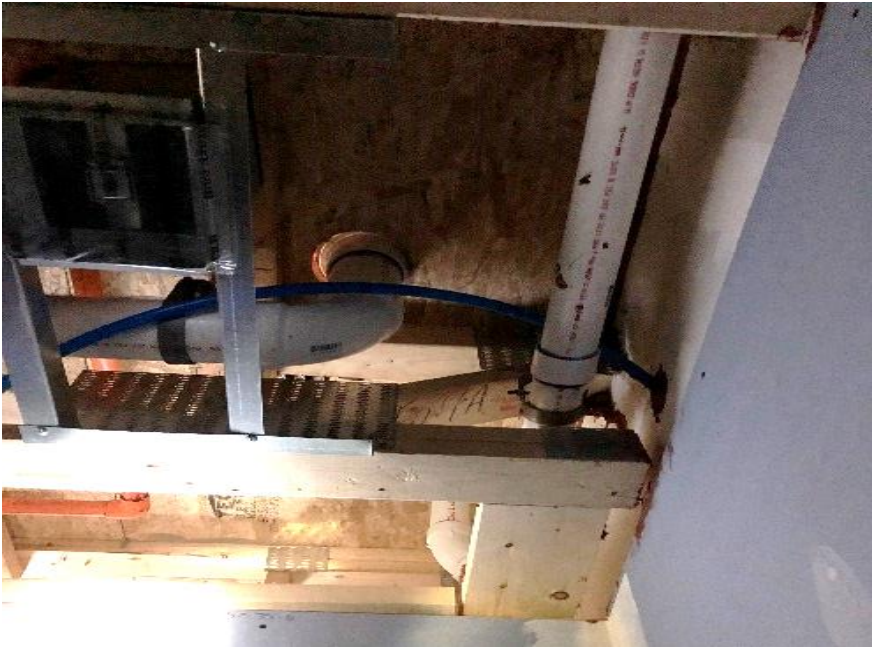
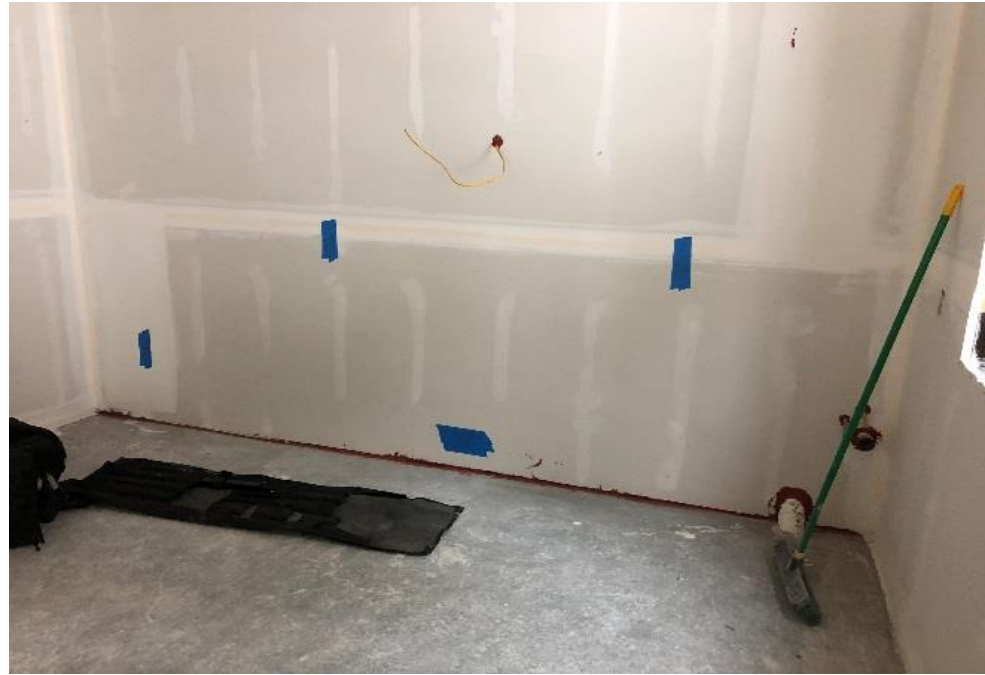
Plumbing penetrations  
OSB Seams in the ceiling  
Interior outlets-around 50 CFM at first

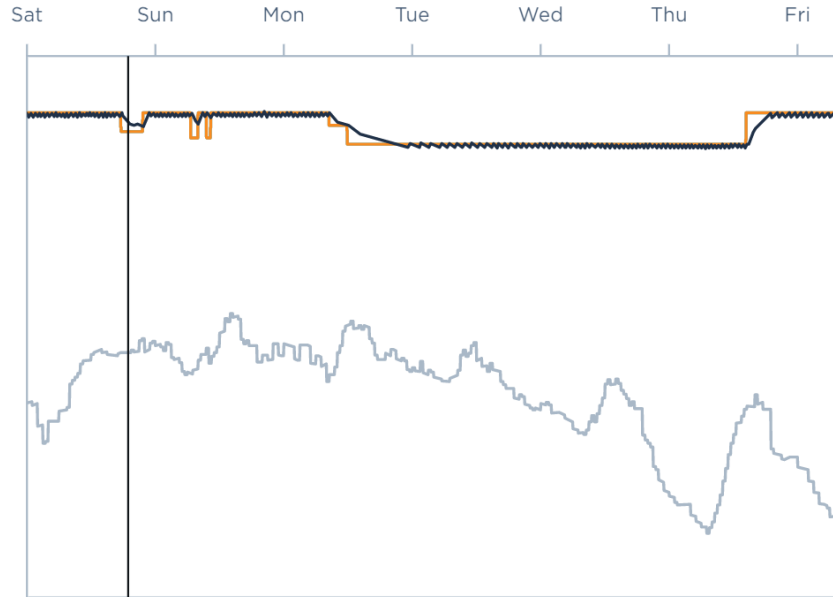
January 25, 2020  
6:55 PM

### Temperature

— Outdoor 36°  
— Indoor 73°  
— Cool 71°  
— Heat 71°

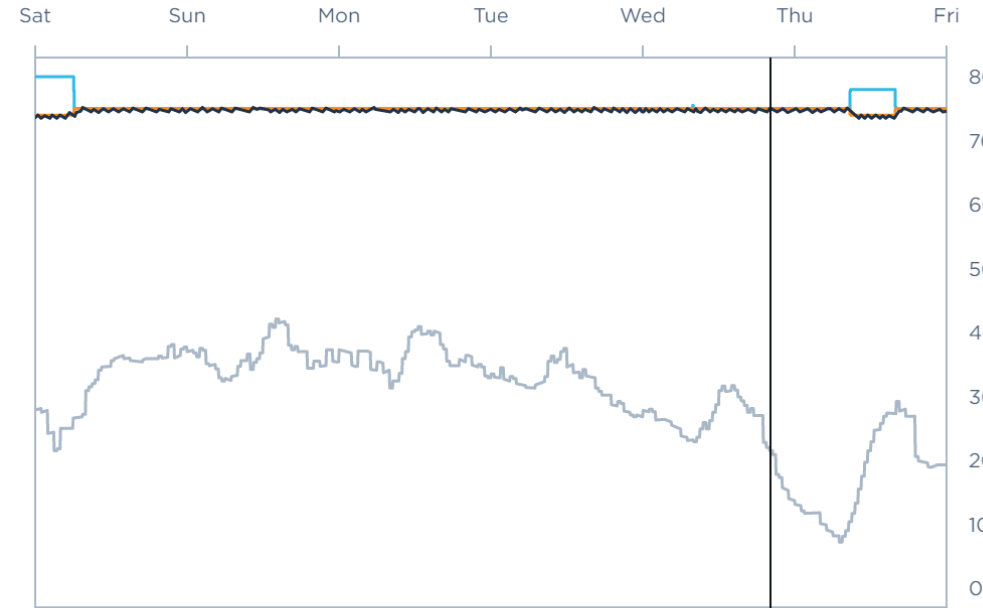
January 29, 2020  
8:10 PM

### Temperature

— Outdoor 22°  
— Indoor 75°  
— Cool 75°  
— Heat 75°

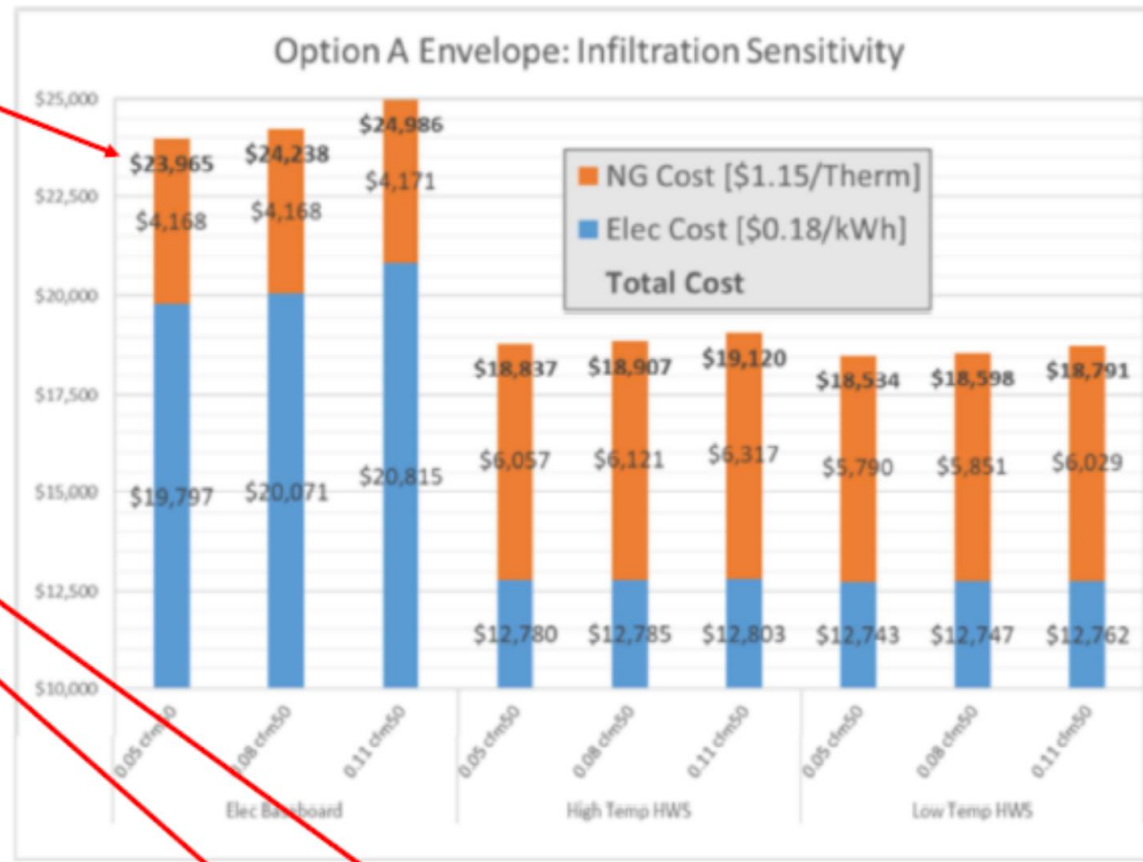
In 4 months, the electric heat and ventilation have consumed \$8,932 of energy. The numbers below look to me like the ERV is providing more heat than anticipated and the electric heat is using much less than predicted.
